# DSS&A DULUTH SLEEPING CAR RESTORATION 2024 PROGRESS REPORT

MID-CONTINENT RAILWAY MUSEUM

NORTH FREEDOM, WI

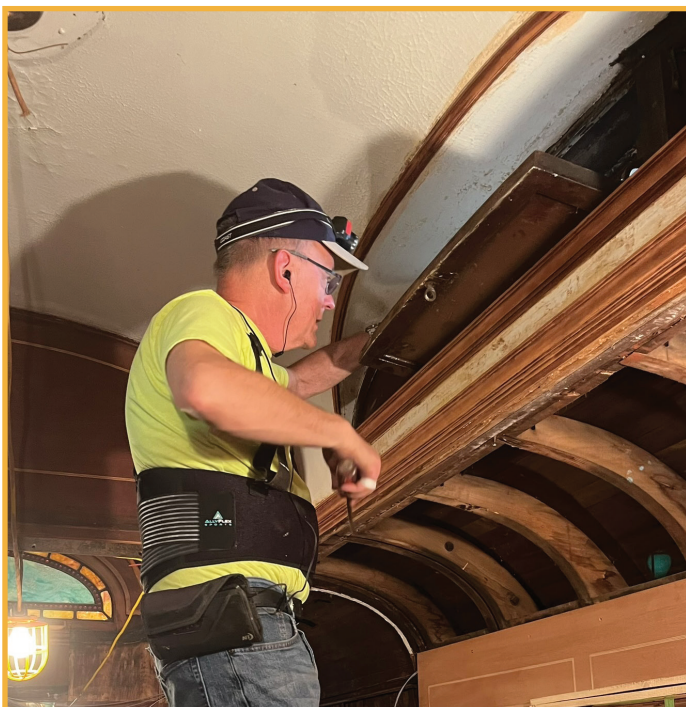
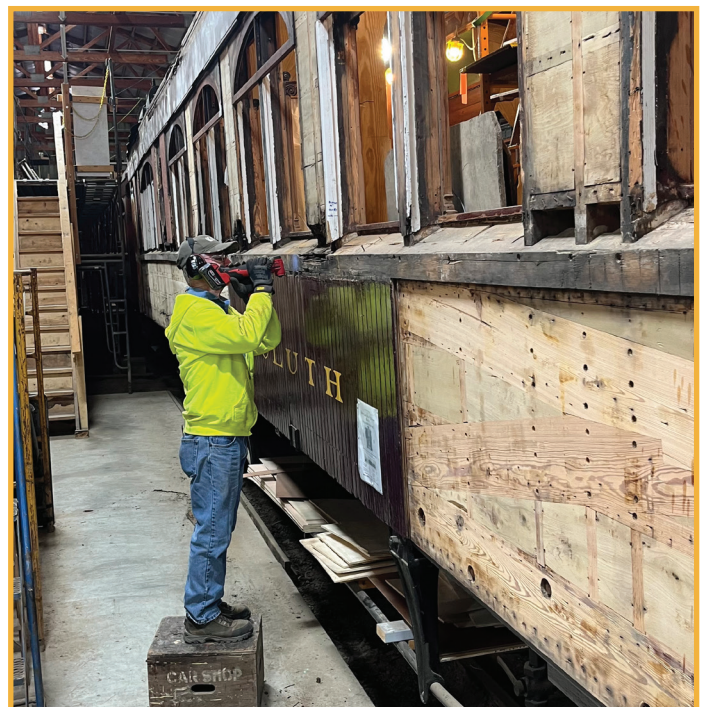
*The last of the original clerestory windows being removed from the car (L) and a portion of the deteriorated belt rail sill in the process of being removed (R).*

- Removed the remnants of the smoking room aisle door framing (in the west wall).
- Removed deteriorated portions of the belt rail sill piece in three locations on the east side.
- Removed the last remaining section of lower siding on the car. This was in the middle of the car, where the car name (DULUTH) was lettered.
- Removed the original wiring, wooden wire trough and metal enclosure from the roof of the car.

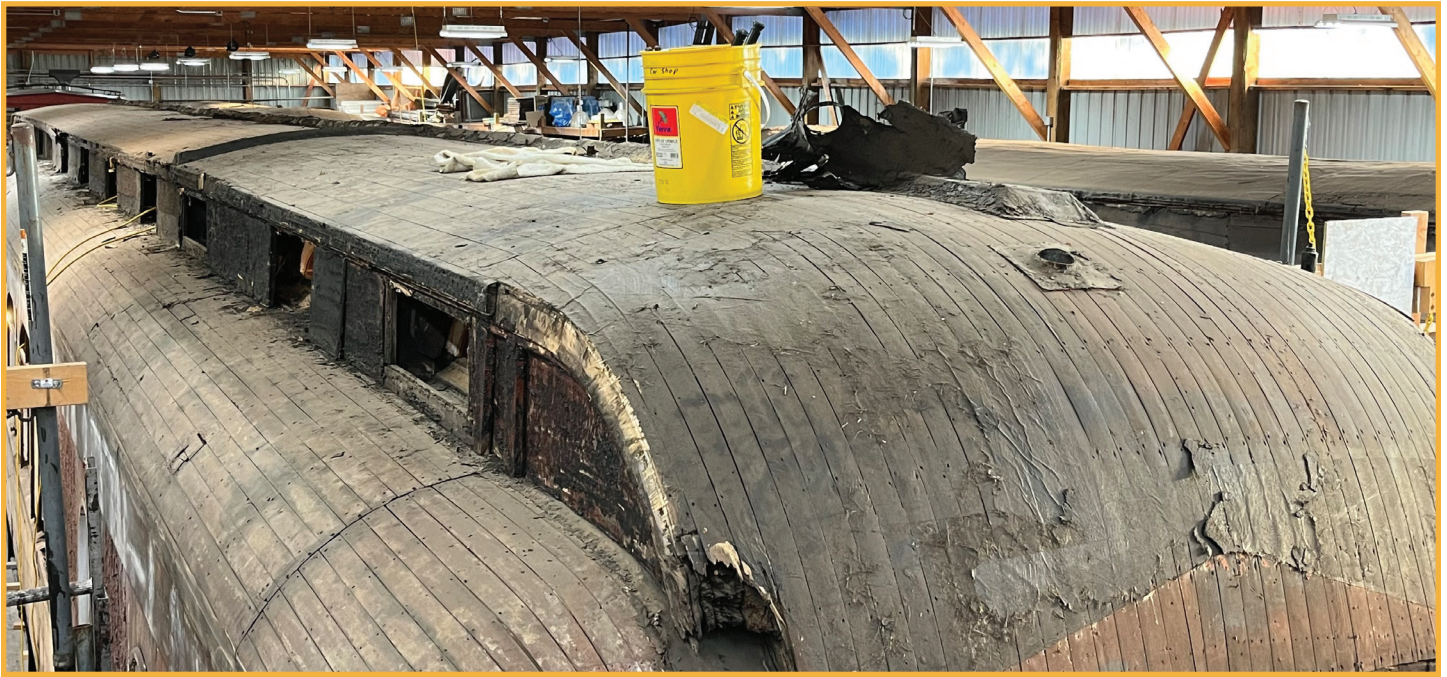
*Before the upper roof wiring, wire trough, and metal enclosure were dismantled and removed.*

Up on the roof volunteers removed all of the original electrical wiring that provided power to the lights throughout the car. The wiring, wire trough and sheet metal enclosure ran the length of the car. This work was done as the insulation on the old wiring was in poor condition and the car's new wiring is being run inside the car framing to eliminate penetrations through the roof.

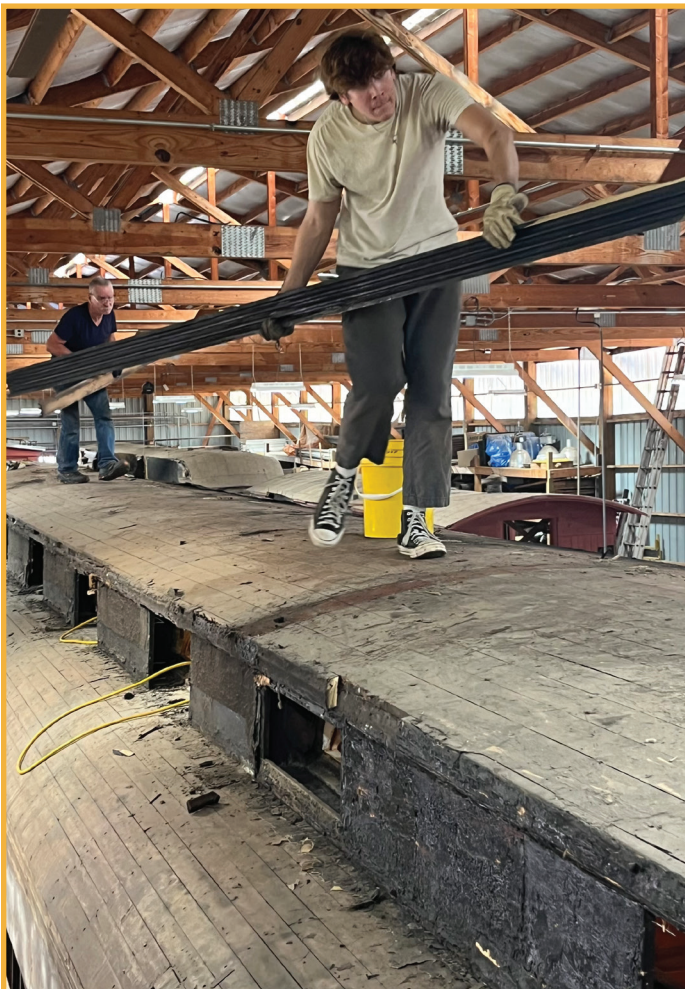
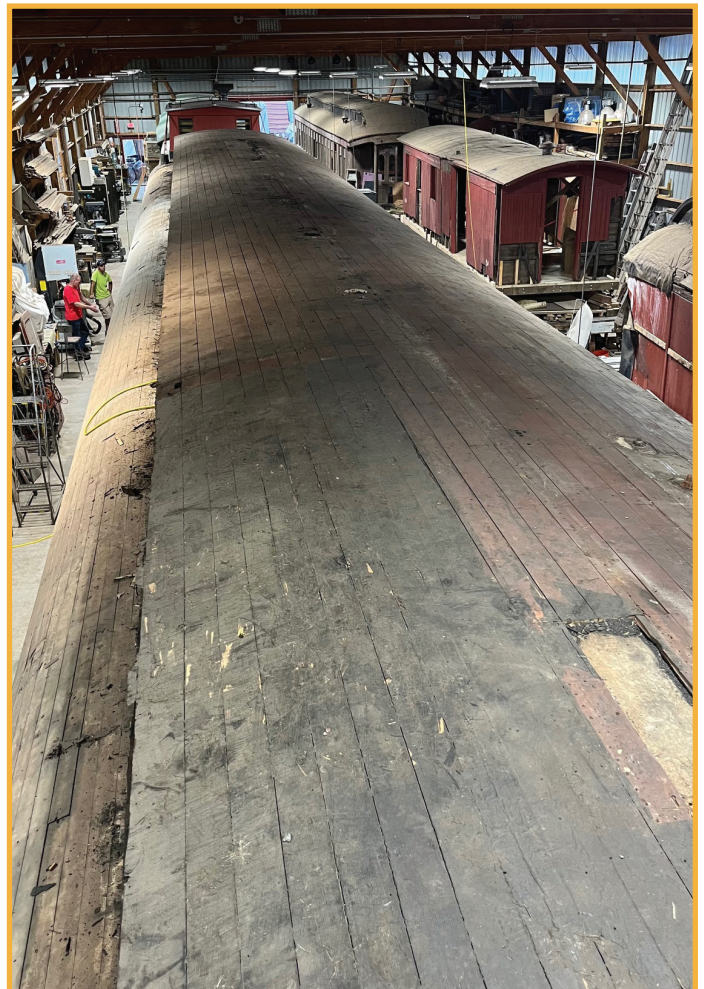
*Volunteers in the process of removing the electrical wiring, etc. off the upper roof (L) and after everything was removed (R).*

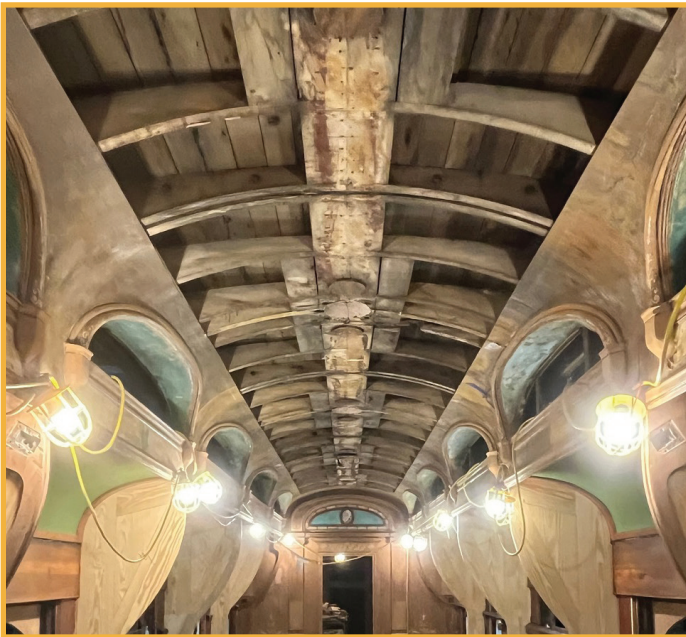
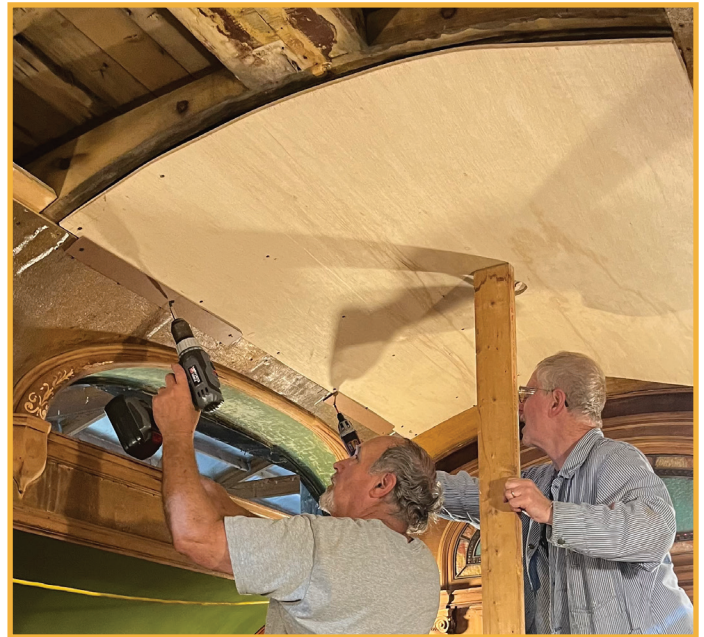
*The ceiling area awaiting replacement (L) and volunteers installing the new bending plywood material (R).*

- Installed new bending plywood in the upper ceiling of the sleeping compartment. This was an area that was approximately 4 feet wide by 30 feet long. All of the joints and the area around each screw were filled with epoxy putty and sanded smooth.
- Installed the new mahogany window header on the east side of the smoking room.
- Installed new mahogany veneer below the window

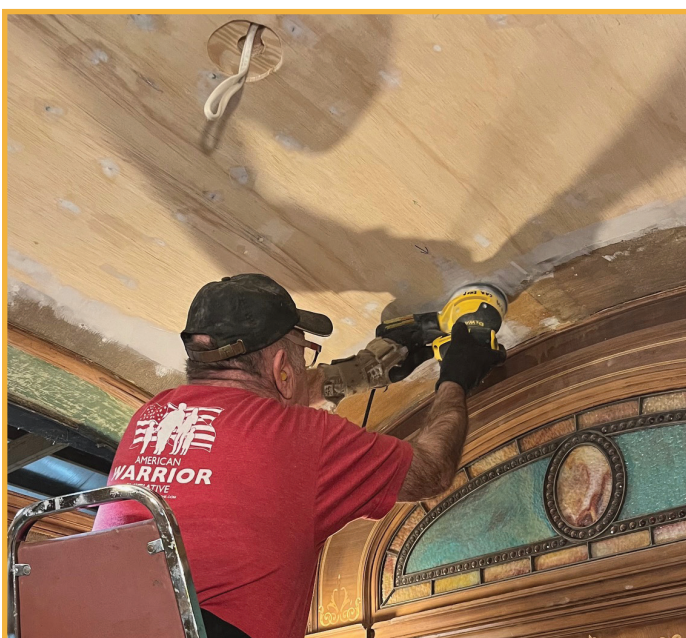
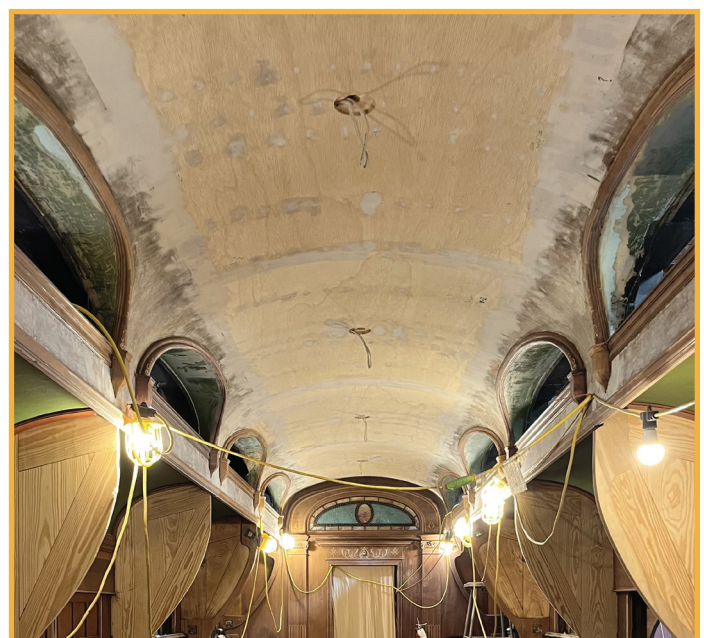
*Sanding the epoxy putty along the joints (R) of the upper ceiling and the completed ceiling after all filling and sanding was completed (R).*

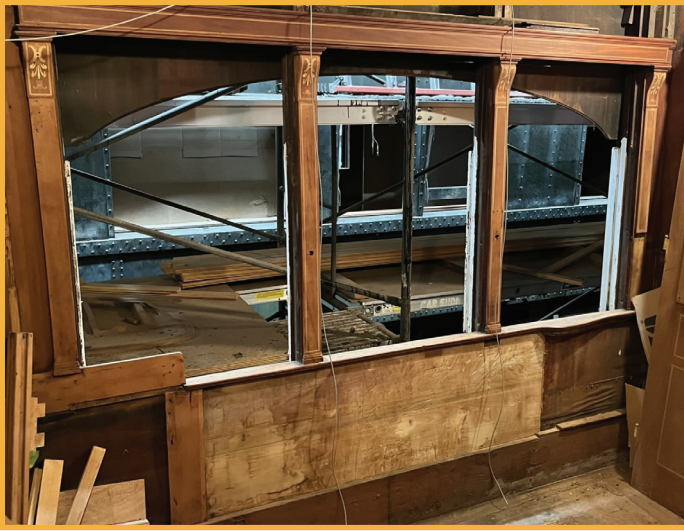
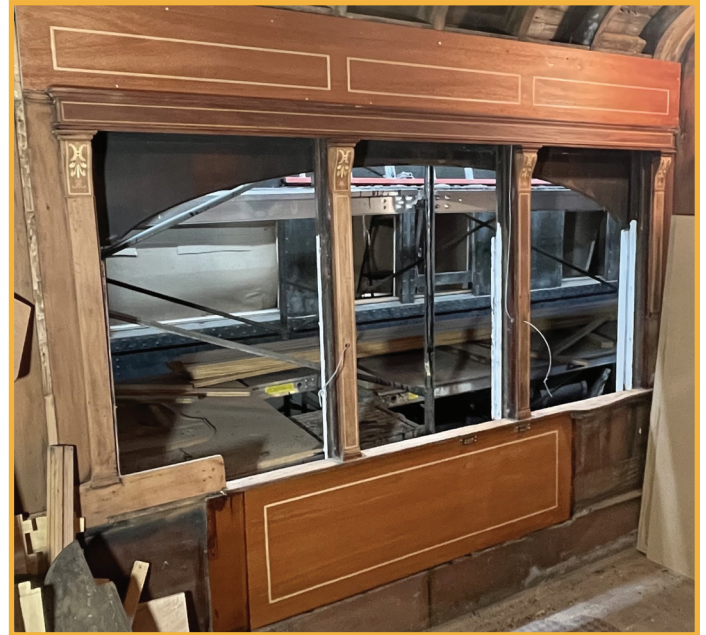
*The smoking room outer wall prior to repairs (L) and after the replicated veneer piece were installed (R).*

In the south end of the car new headlining panels were made and installed in the smoking room and the adjoining aisle. In addition, replica mahogany veneer pieces were installed above and below the east windows in the smoking room. More recently the deteriorated portion of the veneer upper ceiling in the smoking room and entryway were cut out so new pieces can be made and installed. These areas have since been filled with epoxy putty, sanded smooth and ready for paint. The balance of the headliners and

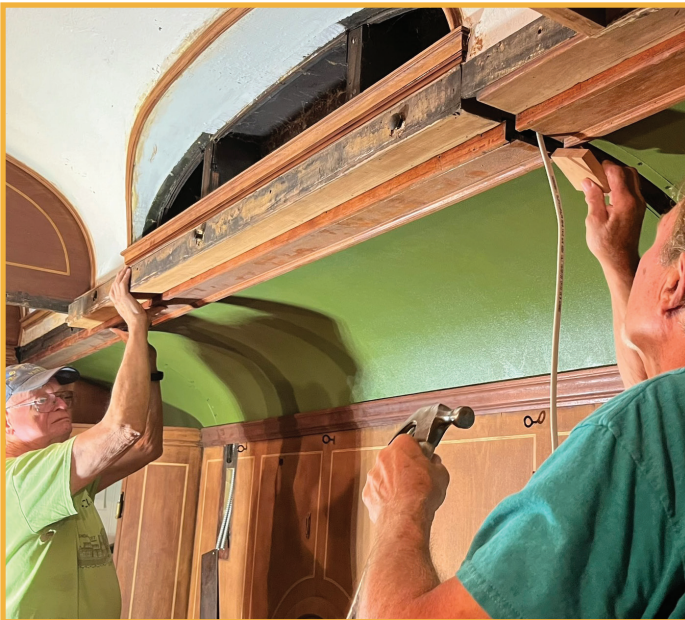
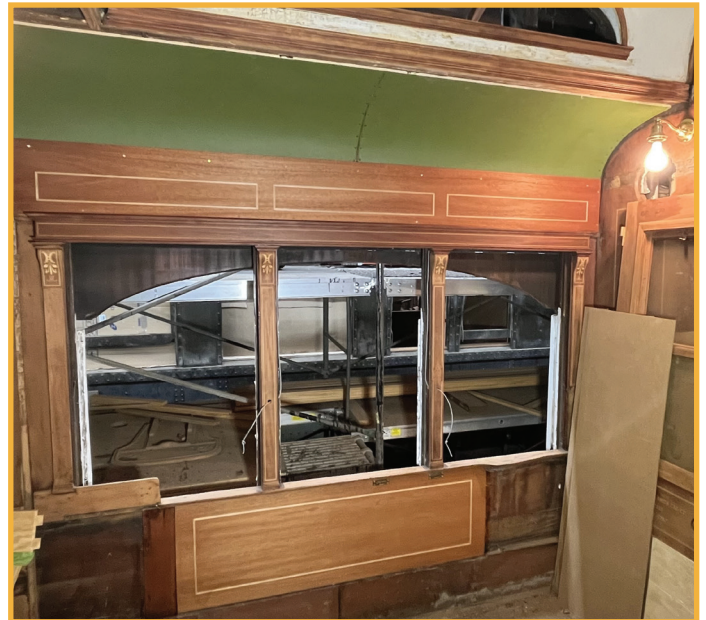
*Installing trim around the new headliner in the aisle across from the smoking room (L).  
The smoking room outer wall with the replicated veneer in place and the new headliners (R).*

- Made new headliner panels for the smoking room and the west aisle. These panels were covered with canvas, painted and installed. This completes the installation of the new headliners in the car.
- Fit and installed the headliner trim on the west side of the smoking room aisle.
- Cut and fit new birch plywood tops for the (2) corner closets in the smoking room area.

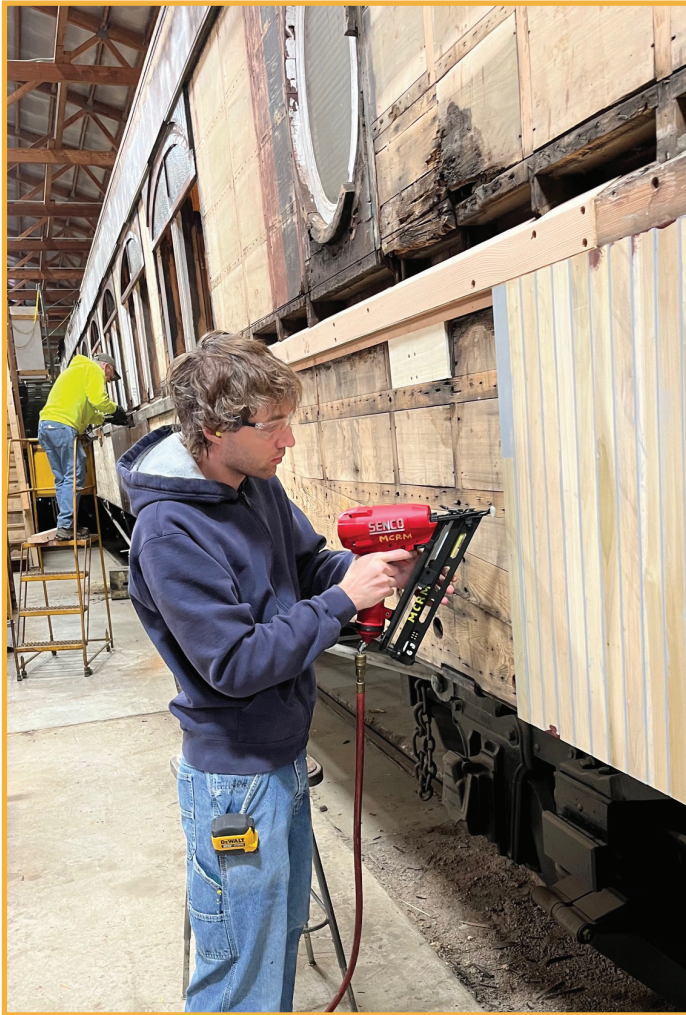
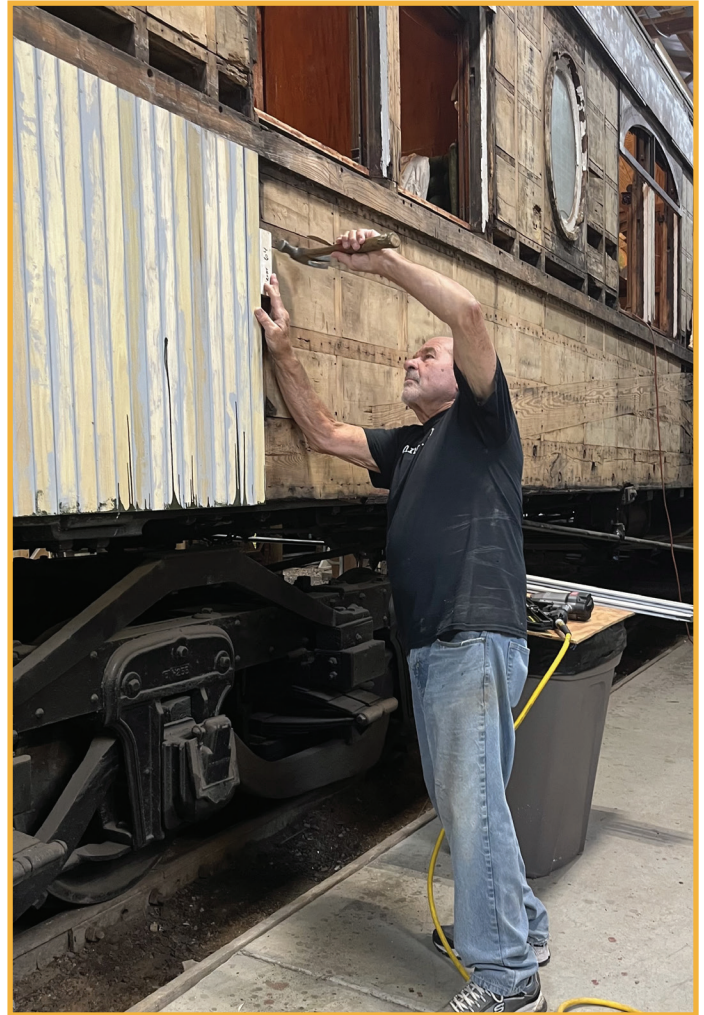
*Volunteers in the process of installing new car siding on the lower portion of the car (R and L). A portion of the replacement belt rail sill is visible above the new siding (L).*

The three locations, totally about 15' in length, required that the deteriorated belt rail sill be cut and removed. Once new yellow pine belt rail sills were made, they were cut, fit and installed on the car. Completing this work allowed us to proceed with installing the lower siding on the car. During the summer over 50% of the new lower car siding was installed on car.

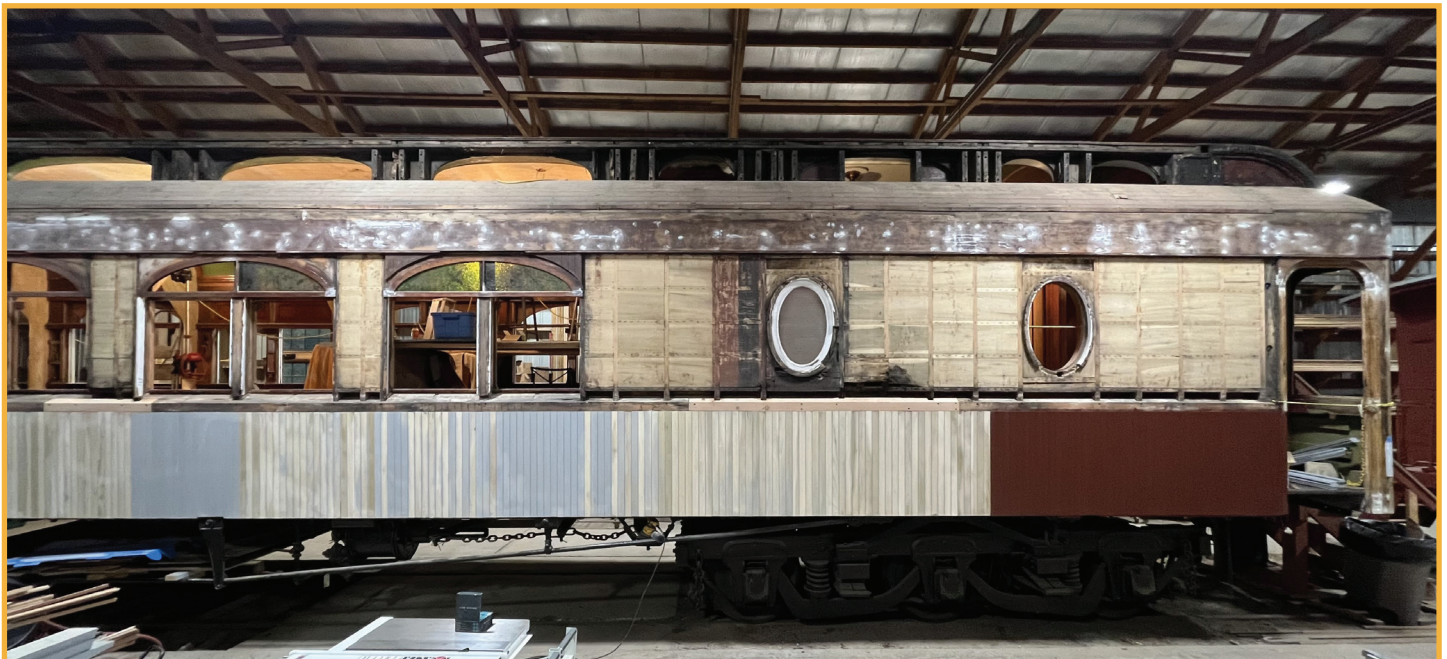
*Some of the new lower siding installed on the car. The portion on the right has the first coat of Tuscan Red tinted primer.*

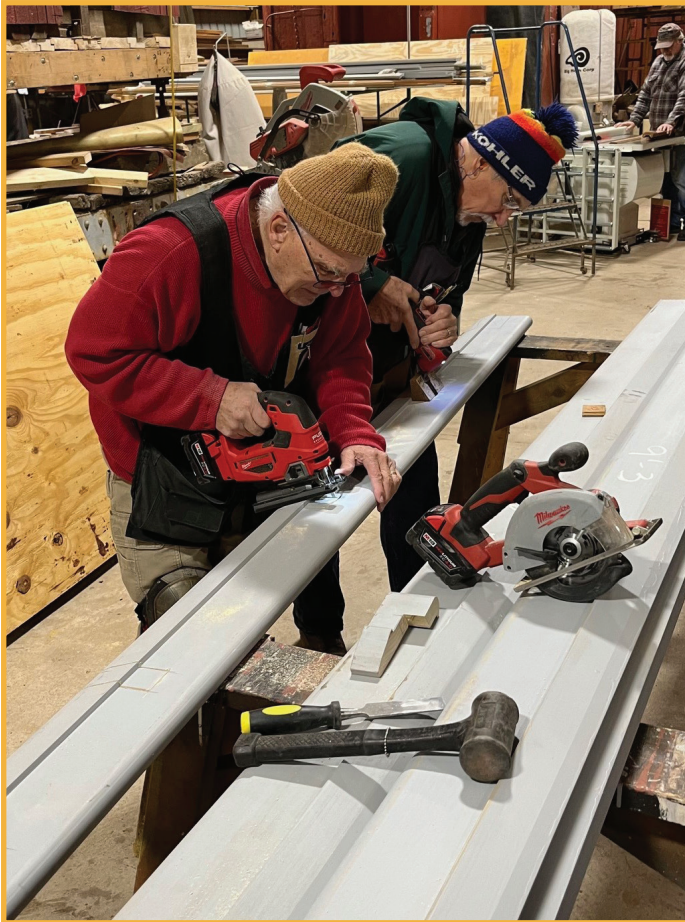
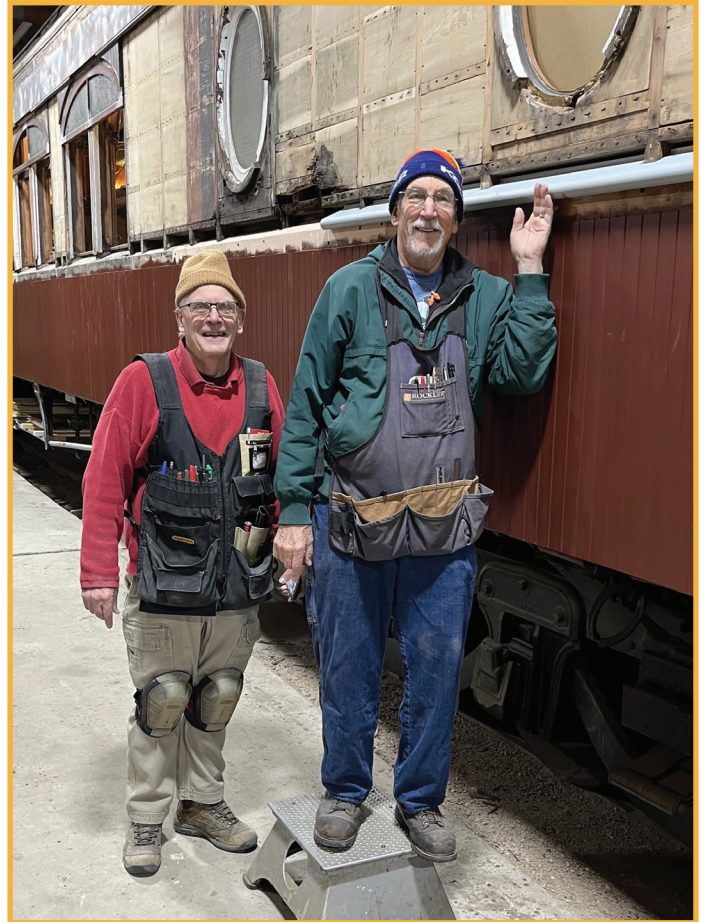
*One of the new window sill pieces being trimmed to fit around the car framing (L) and the first new window sill piece in place on the car (R).*

With the belt rail sill repairs completed it also allowed us to start installing the new window sills on car. The car features a continuous window sill running the entire length of the car. Two of the new custom milled window sill pieces were cut, notched out to go around the car framing and installed on the car. There are six additional window sills needing to be cut and fit on the east side of the car.
